In re Flint Water Cases,
No. 16-cv-1044

Supplemental Report of Dr. Larry L. Russell

October 18, 2022

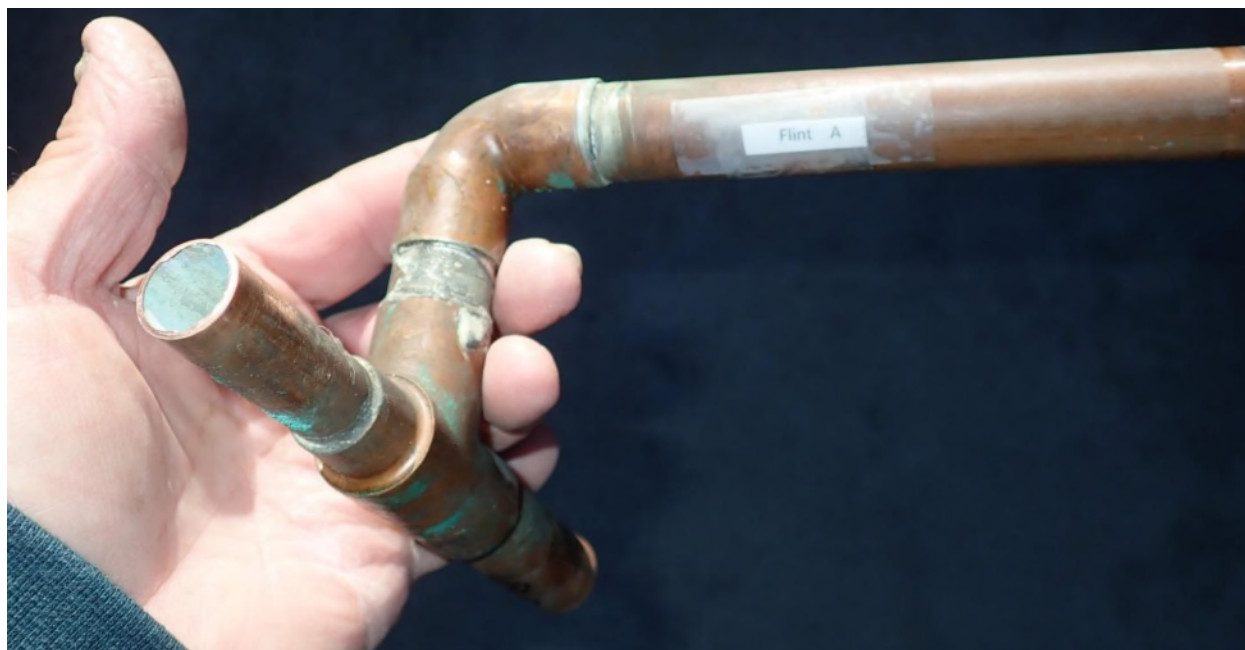
Figure 4.1-1: Pipe sample “A”.

My observations showed that the both hot and cold copper pipes are Type M copper pipe, that was reportedly installed in 2008 during a replumbing of the home to remove the steel piping, were impacted by the exposure to the corrosive Flint River water during the Flint Water Crisis as evidenced by the reduction in wall thickness measured at our metallurgical laboratory. The copper pipe wall was reduced in thickness to the point that 0.002 inches were dissolved. The corrosion rate between 2008 and 2014 and 2016 to 2022 was substantially less than the 0.5 mil per year warranted for the life of copper pipe under the Copper Development Association's 50-year warranty indicating that the DWSD corrosion control program did an excellent job of protecting these pipes from 1967 to 2014.

The copper pipe also showed the existence of a phosphate scale likely deposited by the water treatment chemicals added to the water since the Flint Water Crisis occurred. Thus, it is likely that a substantial amount of this wall thickness was dissolved due to corrosion during the Flint Water Crisis, because this pipe was unprotected due to the absence of the orthophosphate addition. When the addition of orthophosphate was terminated in 2014 simultaneously with the distribution of the substantially more corrosive and high chloride level treated Flint River water distributed throughout the Flint water system, it is clear that conditions were ripe for the rapid corrosion of the copper pipes.

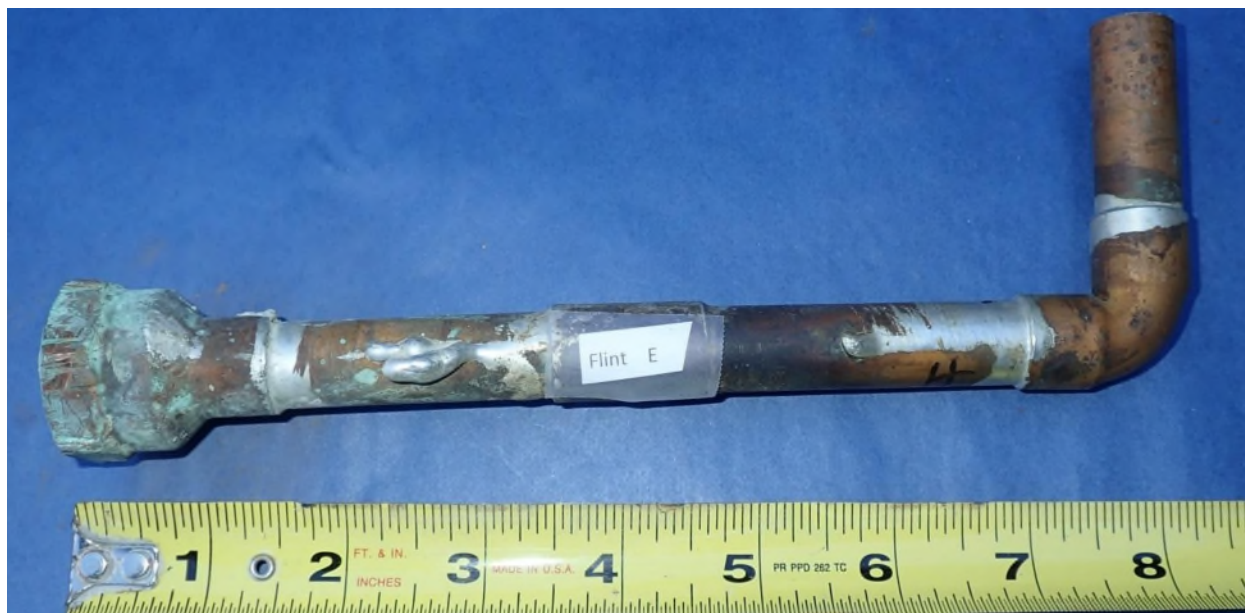
Figure 4.2-1: Pipe sample “E”.

Item ID	Pipe section	Wall Thickness: [Inches]	Wall Thickness: [inches of wall thickness dissolved]	Lead [ppm]	Phosphate [% by weight]
E	Hot – copper pipe to the water heater	0.019*	0.006	Solder: lead free Scale: <1,000	3.97 avg % – 4 measurements
F	Cold – copper pipe to the water heater	0.026*	0.002	Solder: lead free Scale: <1,000	1.96 avg %– 4 measurements
G	Steel pipe tee – corroded through	0.000	0.1	Scale: 41.8 ppm	2.46 avg %– 4 measurements
H	Steel pipe elbow – corroded through	0.000	0.1	Scale: 168 ppm	0.93 avg %–4 measurements
I	Steel nipple and elbow – corroded through	0.000	0.1	Scale: 83.3 ppm	2.48 avg %– 6 measurements

The copper pipe also shows the existence of a phosphate scale deposited by the water treatment chemicals added to the water. Thus, it is likely that a substantial amount of this wall thickness was dissolved due to corrosion during the Flint Water Crisis, because this pipe is currently well protected due to the effectiveness of the orthophosphate addition in reducing copper corrosion. When the addition of orthophosphate was terminated in 2014 simultaneously with the distribution of the substantially more corrosive and high chloride level treated Flint River water distributed throughout the Flint water system, it is clear that conditions were ripe for the rapid corrosion of the copper pipes.

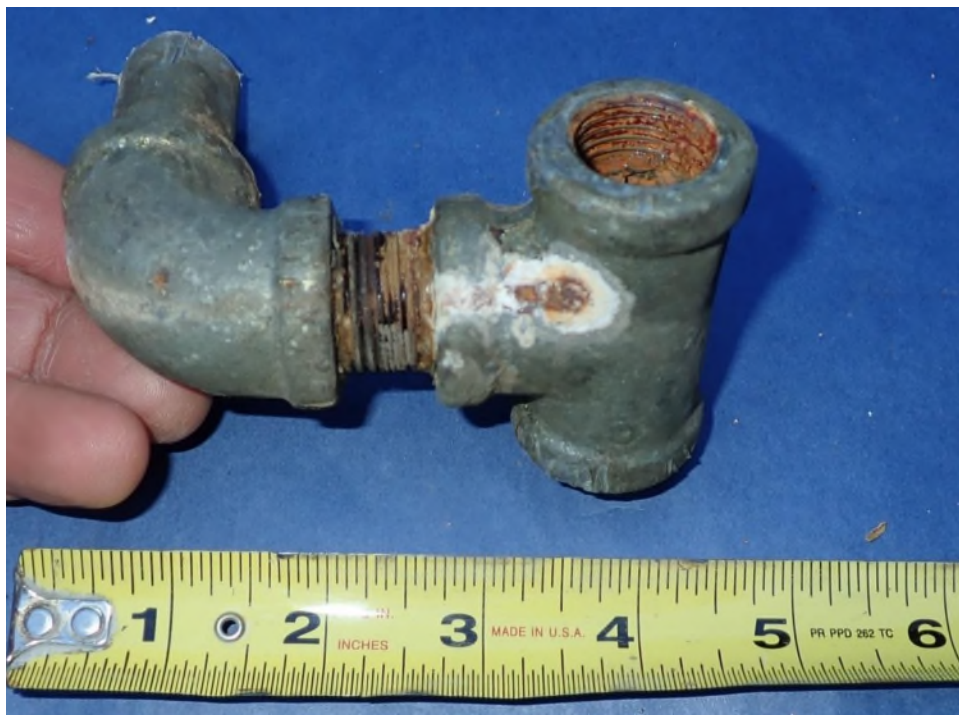
The steel pipe fittings were heavily tuberculated with iron oxide deposits. Under each tubercule is a pit that will penetrate the wall at some point in time (this had already occurred in samples labeled Flint G and H). The lead concentration in the scale on pipes G,H, I was 41.8, 168, 83.3 ppm, respectively, which are substantial lead concentrations that would be solubilized if the water became more corrosive (as it did during the Flint Water Crisis) and/or the corrosion inhibition program failed due to insufficient addition of chemicals.

Figure 4.2-6: Pipe sample “G”. Note the corrosion and scale present on the exterior of the tee indicative of a through wall leak.

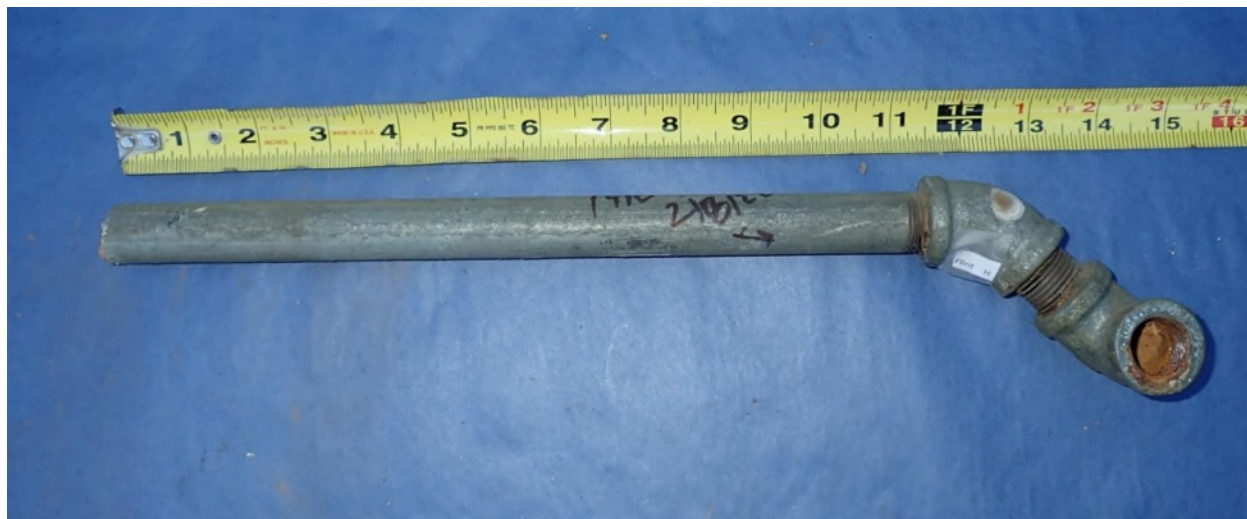
Figure 4.2-8: Pipe sample “H”. Note the corrosion and scale present (white spot) on the exterior of the elbow indicative of a through wall leak.
